THE COMPLICATIONS OF AUGMENTATION RHINOPLASTY IN ORIENTALS

By YASUO MUTOU, M.D.

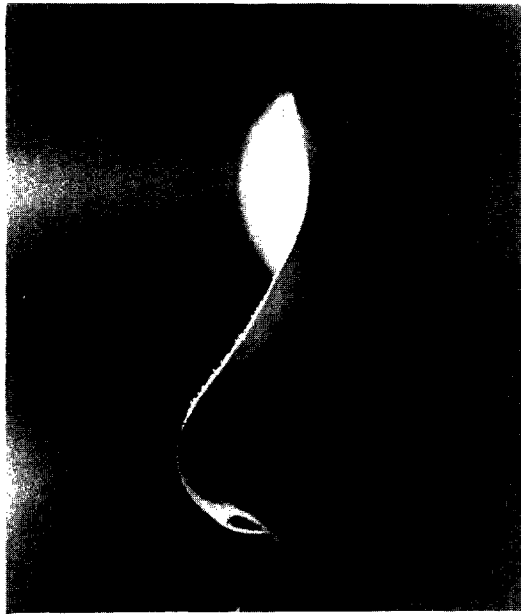
FIG. 1. Translucency imparted to the nose by a clear silicone prosthesis. Opaque white material is preferred.

After ivory, I used a carved silicone rubber implant; one which was black in colour was discarded after many patients complained of a bluish discoloration over the dorsum of the nose. An acrylic implant which was reddish in colour transmitted a pinkish blue hue to the dorsum; a clear silicone rubber prosthesis also caused a pinkish discoloration to appear, especially in light complexioned individuals, when the nose was exposed to the rays of the sun or even an electric light (Fig. 1). After such experiences, silicon rubber prostheses which are milky white in colour are now mostly used.

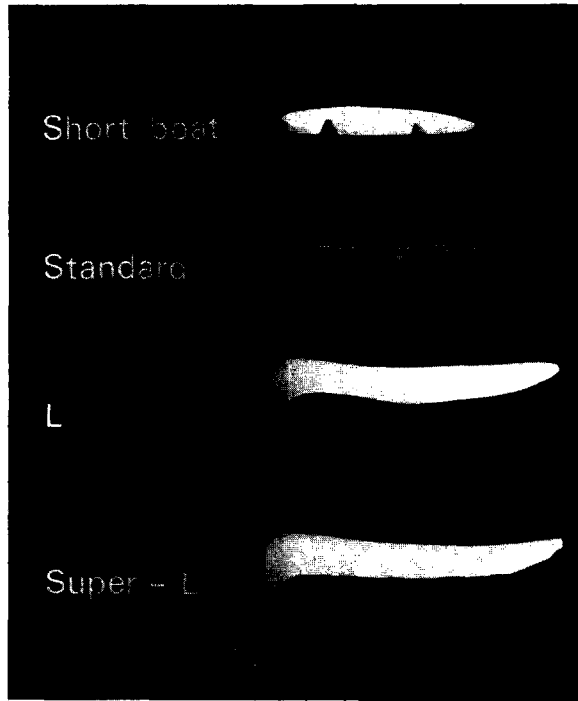
FIG. 2. Evolution of the L-shaped prosthesis. Both the boat-shaped and standard types tend to drift upwards.

The old ivory and the early silicone prosthesis were carved to a short boat shape and fixation depended on perforations or serrations. Because of the tendency to upward drift a short columellar hook was added. Some of these too drifted upward and an L-shaped prosthesis was developed. This provides full stabilisation of the prosthesis at the tip, as well as over the dorsum. The base of the L is approximately 1 or 2 mm in thickness and in width and is inserted into a pocket dissected into the junction of the septum and columella. The "super L-shaped" prosthesis, adds a slight increase in the width of the terminal portion of the L to increase the columellar-labial angle as well as elevating the nasal tip (Fig. 2).

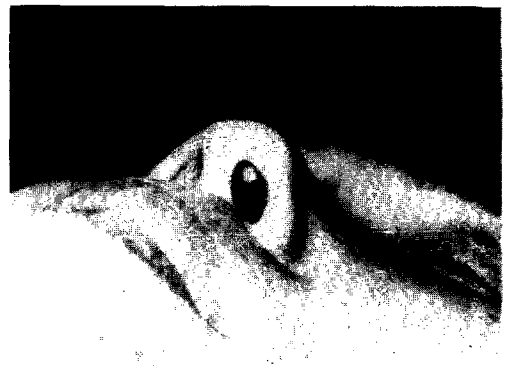
FIG. 4. Protrusion through the side of the incision.

A perforation at the site of the operative incision occurs frequently as a result of the prosthesis tip being too wide and bulky (Fig. 4). This is clearly a failure in design of the implant.

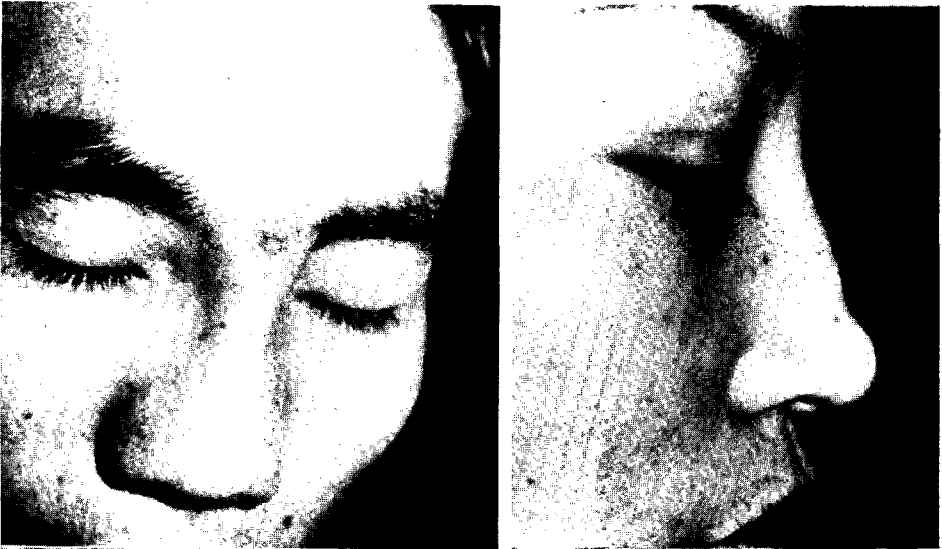
FIG. 5. Protrusion on the dorsum.

FIG. 6. Step deformity due to boat-shaped prosthesis moving upward.

A perforation may occur at the upper end of the implant over the nasal dorsum, due, in the case shown, to an initial perforation at the operative site in the nasal vestibule with secondary infection extending over the dorsum (Fig. 5).

Malposition. The step-like deformity due to upward displacement of a short boat type ivory prosthesis occurs because of failure of fixation (Fig. 6). A lesser degree of upward drift may occur with a standard shaped silicone prosthesis. The prosthesis tip causes an elevation of the upper tip region instead of a step (Fig. 7). Each of these cases was corrected by removal of the implants and insertion of an L-shaped prosthesis.

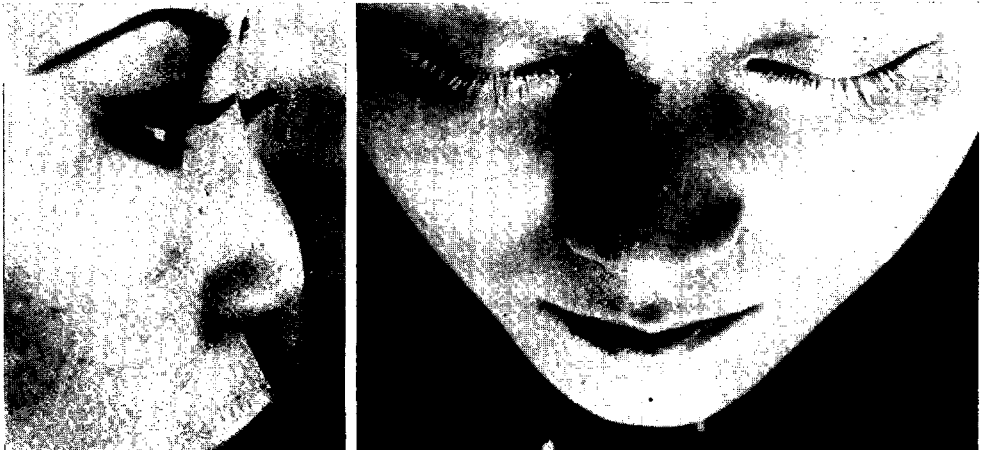
FIG. 7. Deformity resulting from upward drift of the standard shaped prosthesis.

FIG. 8. Lateral displacement from asymmetrical undermining or fixation.

When the undermining over the nasal dorsum has been asymmetrical or incomplete, the prosthesis may be displaced laterally (Fig. 8). Possibly the post-operative fixation had also been inaccurately applied. Correction of this complication involved removal and replacement after adequate symmetrical undermining.
